PRELIMINARY ASSESSMENT REPORT

LANE STREET GROUND WATER CONTAMINATION

ELKHART, INDIANA

OCTOBER 5, 2007

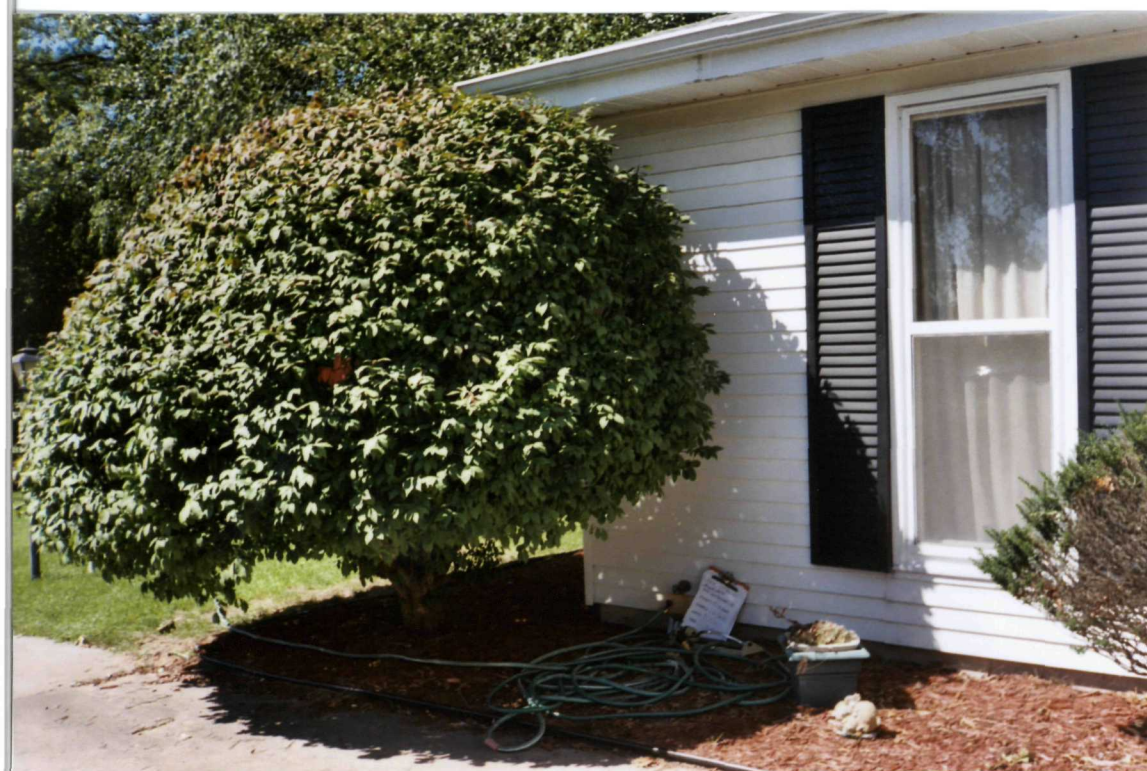
SITE: Lane Street Ground Water Contamination  
EPA ID#: INN000510229  
DATE: 8/31/07  
TIME: 11:50 am  
WEATHER: Sunny; 80s °  
SAMPLE ID# LQ 4610  
SAMPLE TYPE: Ground Water  
DESCRIPTION: Ground water sample obtained from 23741 Barley Street

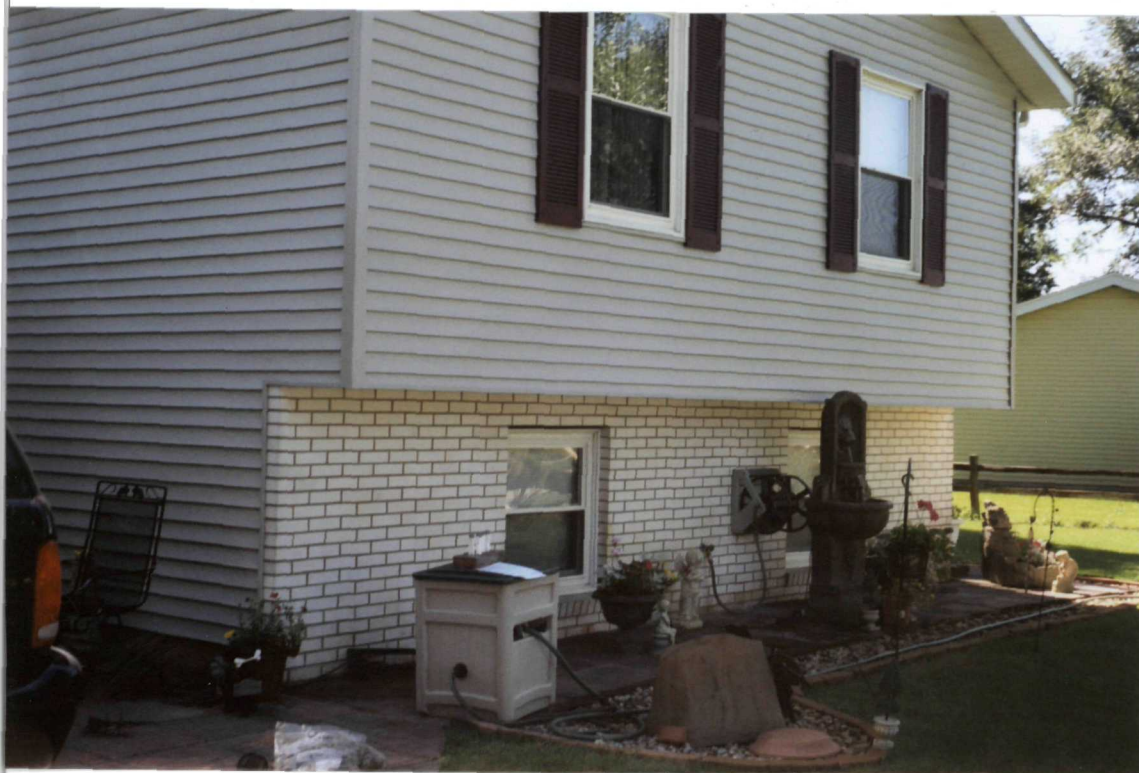
**SITE: Lane Street Ground Water Contamination**  
**EPA ID#: INN000510229**  
**DATE:8/31/07**  
**TIME: 11:50 am**  
**WEATHER: Sunny; 80s °**  
**SAMPLE ID# LQ 4592**  
**SAMPLE TYPE: Ground Water**  
**DESCRIPTION: Picture shows the area where sample LQ4592 was obtained**

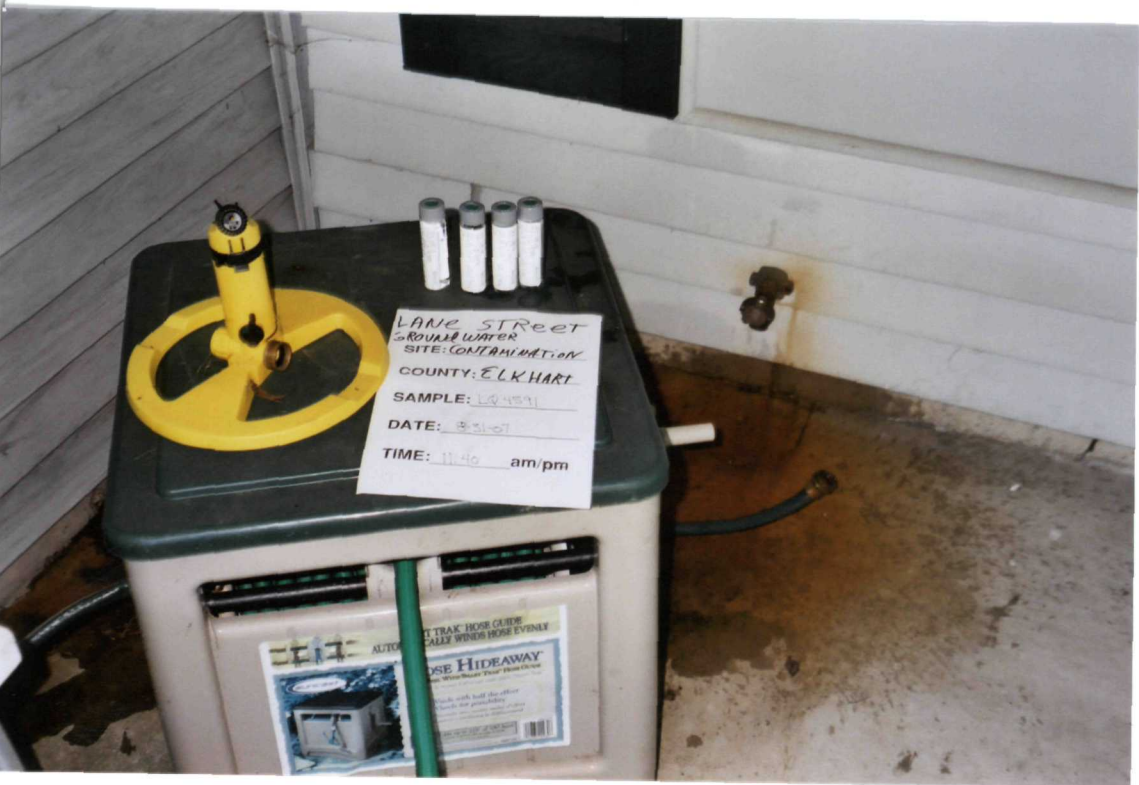
**SITE: Lane Street Ground Water Contamination**  
**EPA ID#: INN000510229**  
**DATE:8/31/07**  
**TIME: 11:40 am**  
**WEATHER: Sunny; 80s °**  
**SAMPLE ID# LQ 4591**  
**SAMPLE TYPE: Ground Water**  
**DESCRIPTION: Ground water sample obtained from 53668 Lane Street**

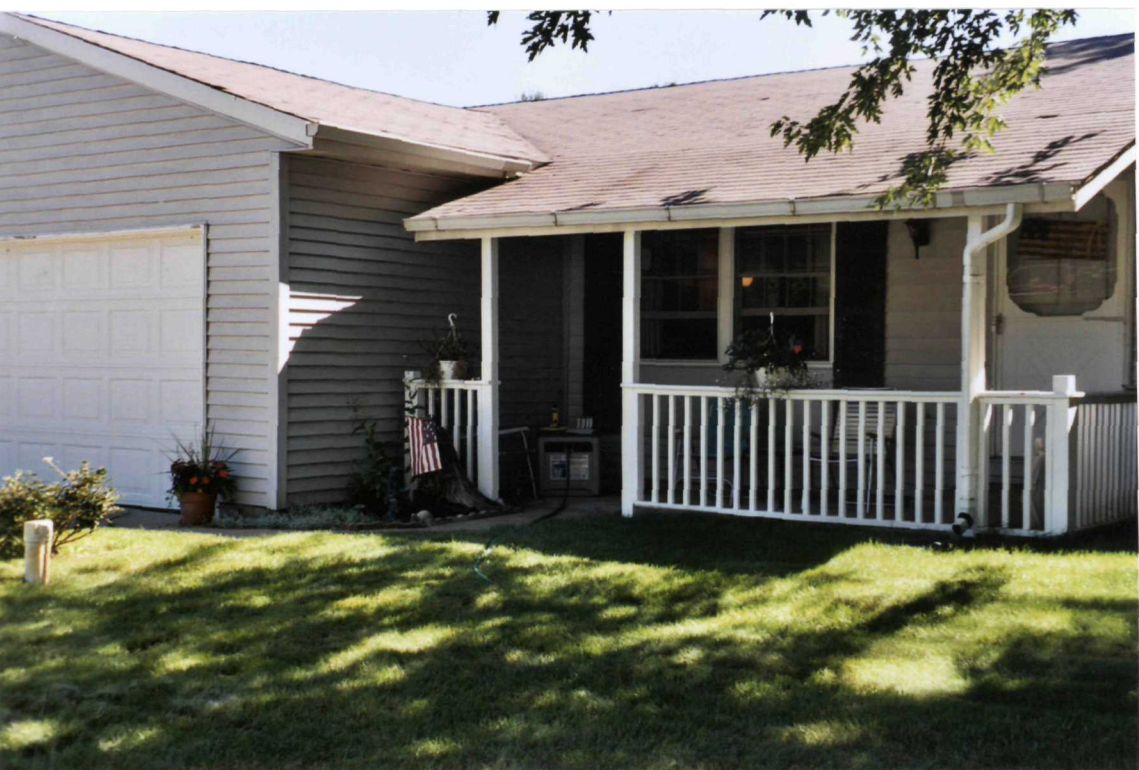
**SITE: Lane Street Ground Water Contamination**  
**EPA ID#: INN000510229**  
**DATE:8/31/07**  
**TIME: 11:40 am**  
**WEATHER: Sunny; 80s °**  
**SAMPLE ID# LQ 4591**  
**SAMPLE TYPE: Ground Water**  
**DESCRIPTION: Picture shows the area where sample LQ4591 was obtained**

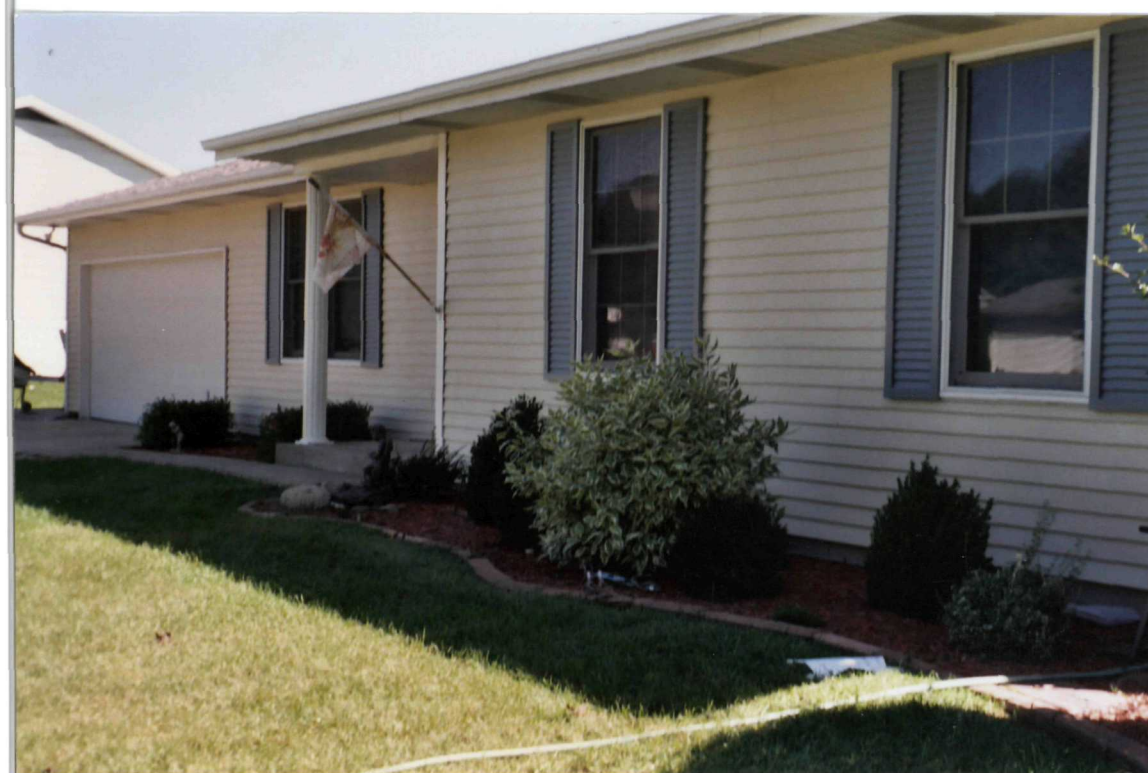
SITE: Lane Street Ground Water Contamination  
EPA ID#: INN000510229  
DATE: 8/31/07  
TIME: 11:30 am  
WEATHER: Sunny; 80s °  
SAMPLE ID# LQ 4690  
SAMPLE TYPE: Ground Water  
DESCRIPTION: Picture shows the area where sample LQ4690 was obtained

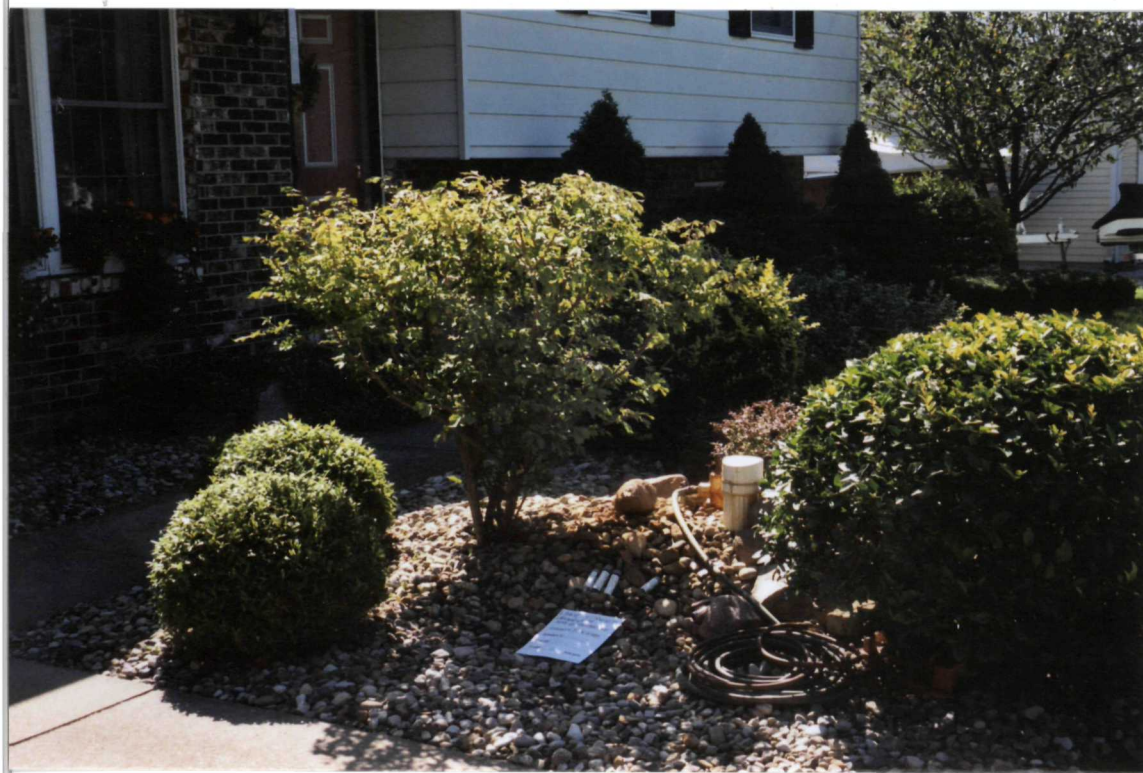
SITE: Lane Street Ground Water Contamination  
EPA ID#: INN000510229  
DATE: 8/31/07  
TIME: 11:20 am  
WEATHER: Sunny; 80s °  
SAMPLE ID# LQ 4589  
SAMPLE TYPE: Ground Water  
DESCRIPTION: Picture shows the area where sample LQ4589 was obtained

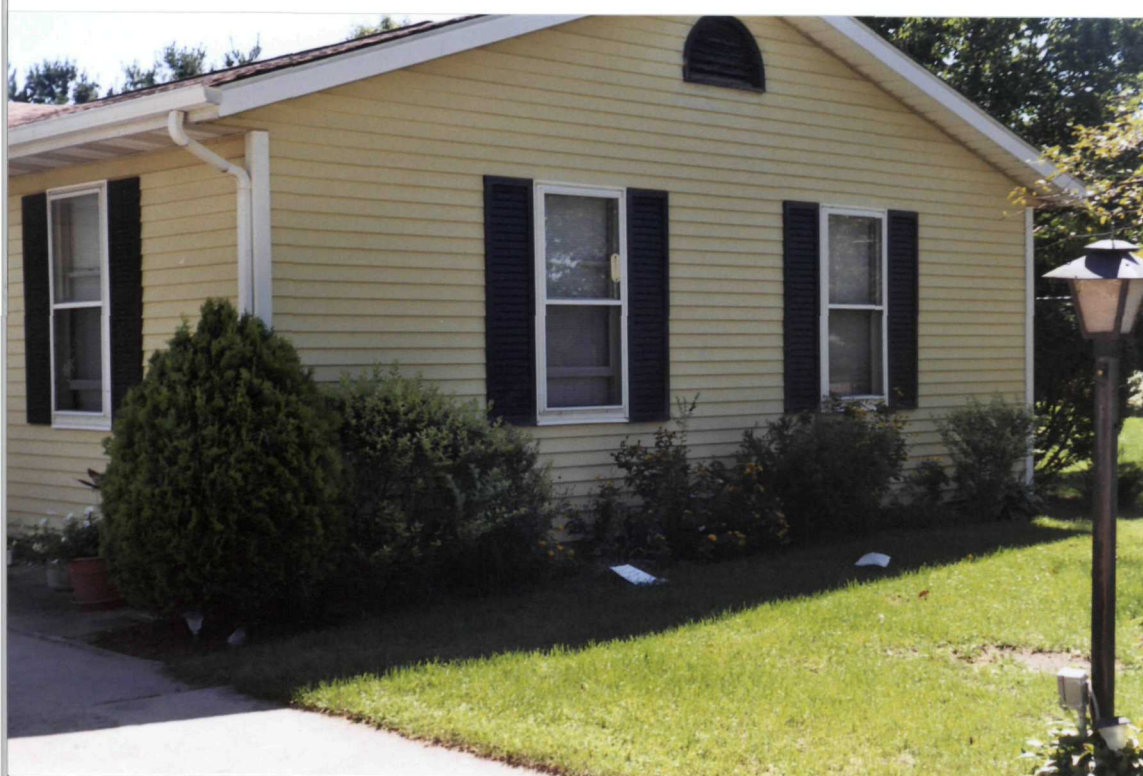
SITE: Lane Street Ground Water Contamination  
EPA ID#: INN000510229  
DATE: 8/31/07  
TIME: 11:10 am  
WEATHER: Sunny; 80s °  
SAMPLE ID# LQ 4588  
SAMPLE TYPE: Ground Water  
DESCRIPTION: Picture shows the area where sample LQ4588 was obtained

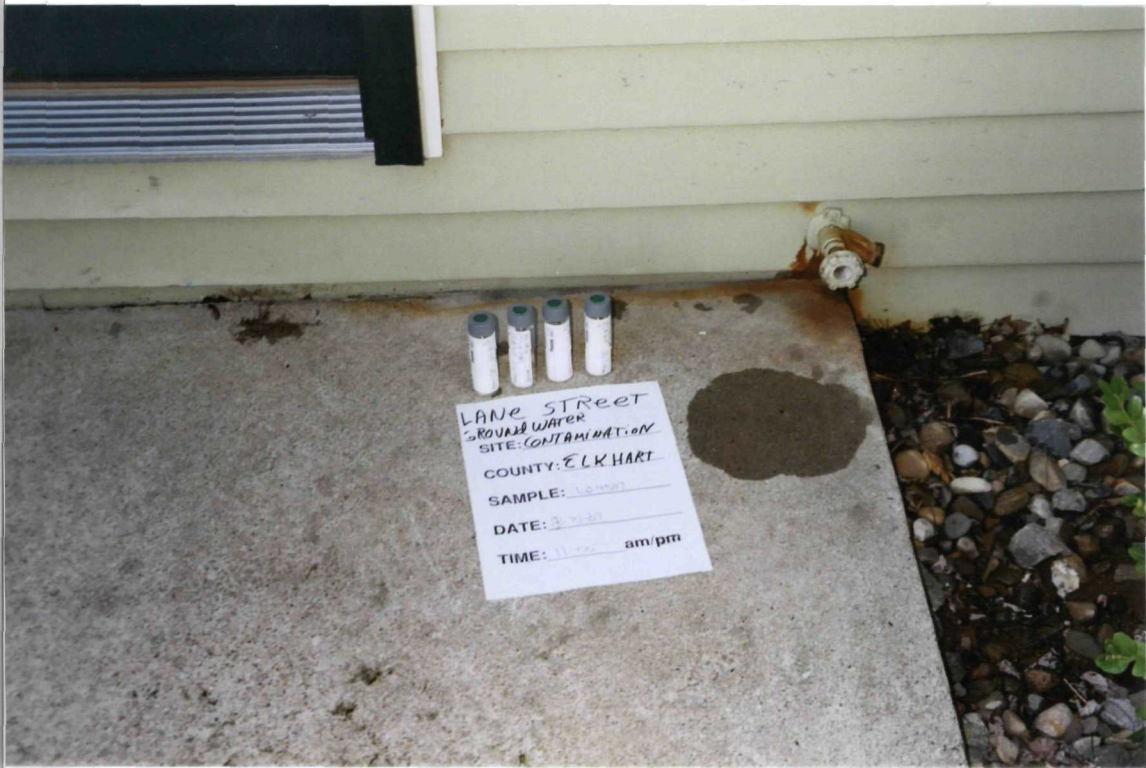
**SITE: Lane Street Ground Water Contamination**  
**EPA ID#: INN000510229**  
**DATE: 8/31/07**  
**TIME: 11:00 am**  
**WEATHER: Sunny; 80s °**  
**SAMPLE ID# LQ 4587**  
**SAMPLE TYPE: Ground Water**  
**DESCRIPTION: Ground water sample obtained from 53604 Lane Street**

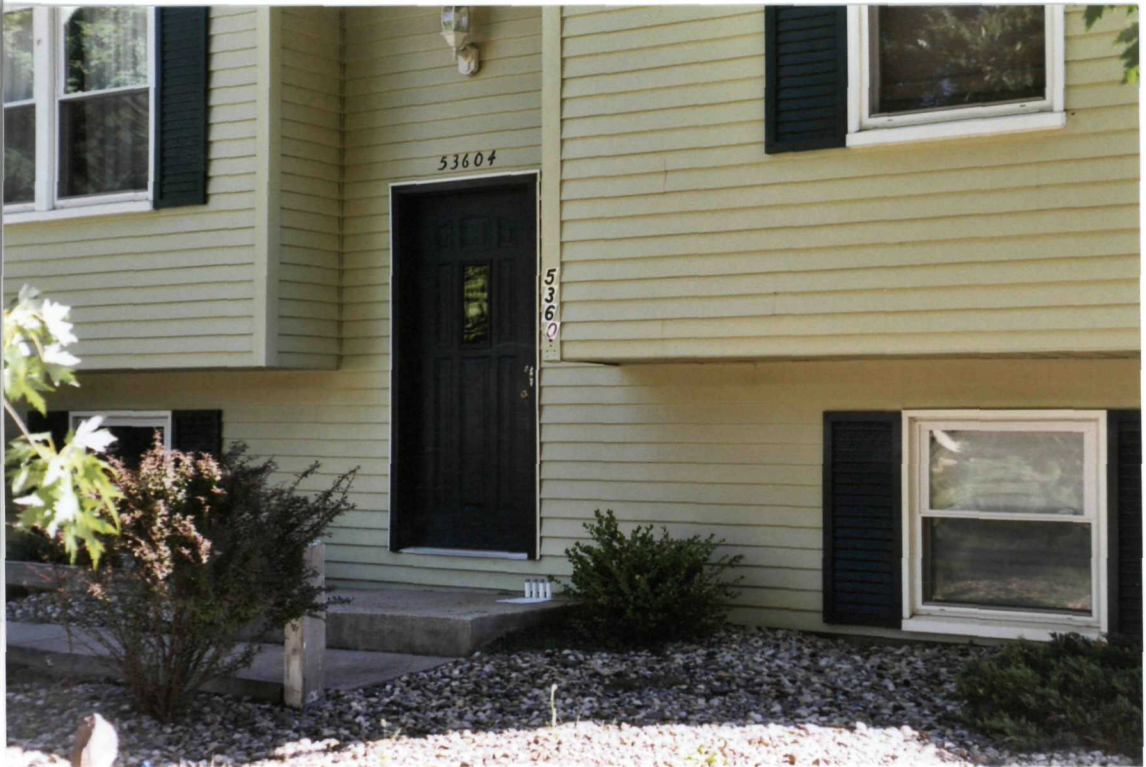
**SITE: Lane Street Ground Water Contamination**  
**EPA ID#: INN000510229**  
**DATE: 8/31/07**  
**TIME: 11:00 am**  
**WEATHER: Sunny; 80s °**  
**SAMPLE ID# LQ 4587**  
**SAMPLE TYPE: Ground Water**  
**DESCRIPTION: Picture shows the area where sample LQ4587 was obtained**

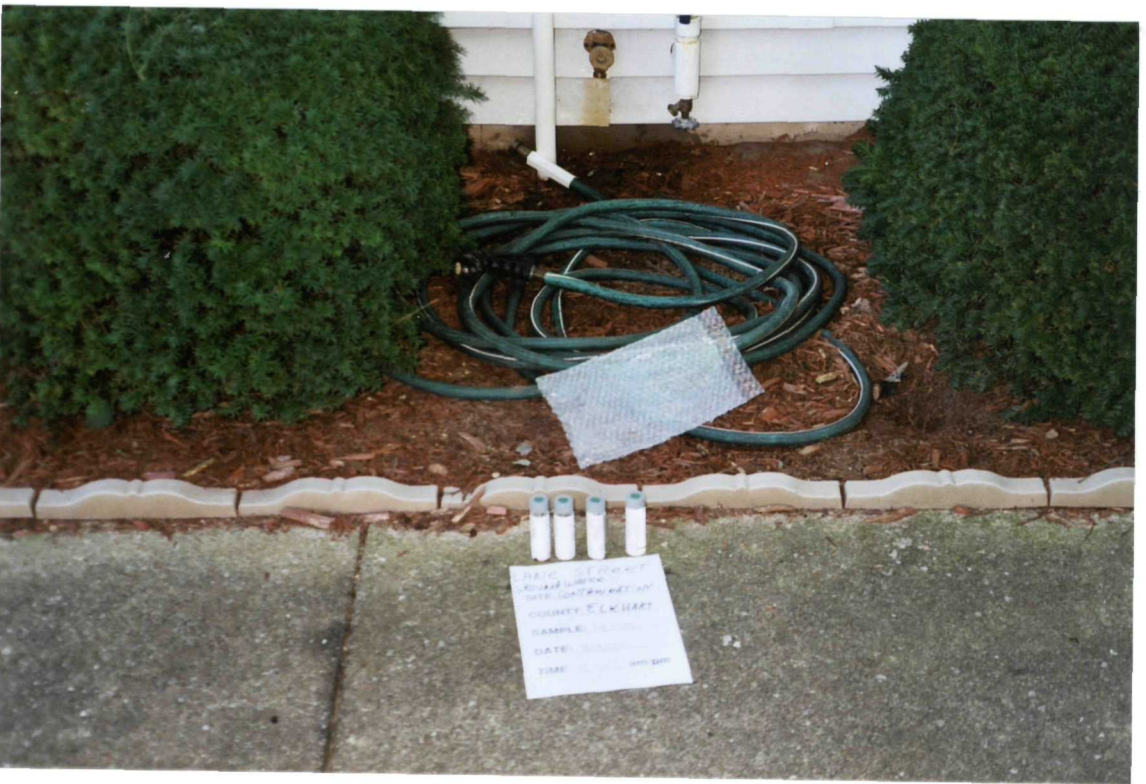
**SITE: Lane Street Ground Water Contamination**  
**EPA ID#: INN000510229**  
**DATE: 8/31/07**  
**TIME: 10:50 am**  
**WEATHER: Sunny; 80s °**  
**SAMPLE ID# LQ 4586**  
**SAMPLE TYPE: Ground Water**  
**DESCRIPTION: Ground water sample obtained from 53584 Lane Street**

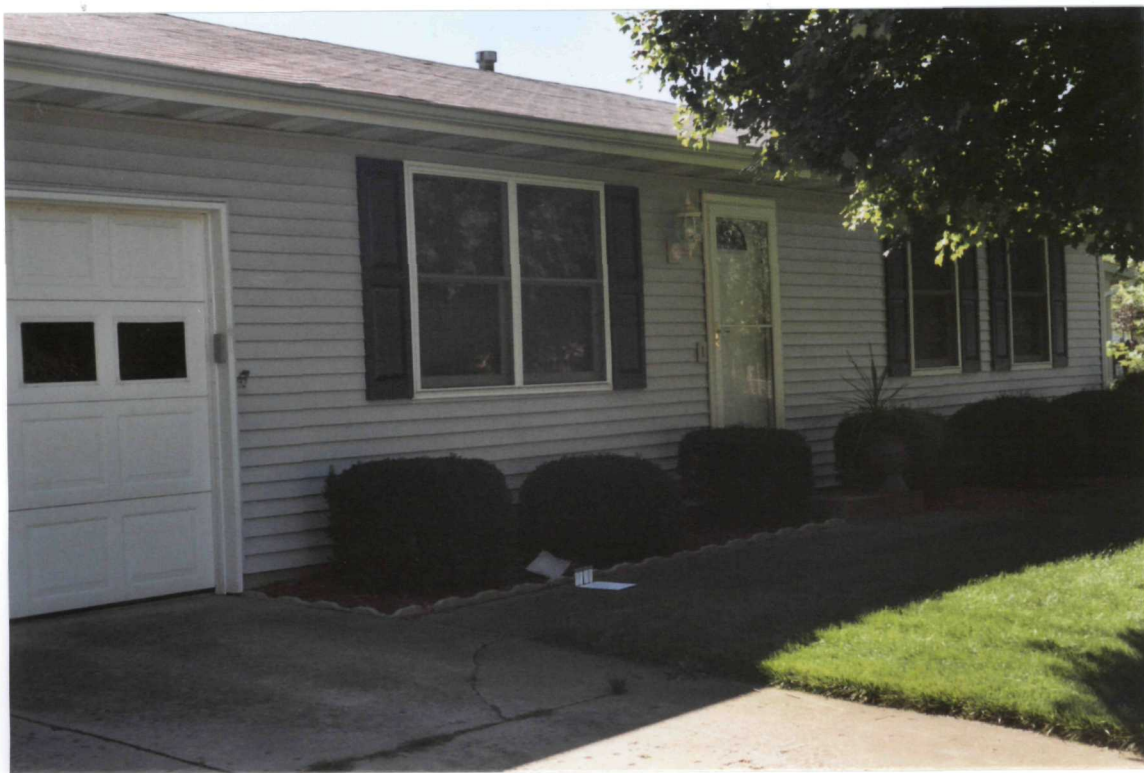
**SITE: Lane Street Ground Water Contamination**  
**EPA ID#: INN000510229**  
**DATE:8/31/07**  
**TIME: 10:50 am**  
**WEATHER: Sunny; 80s °**  
**SAMPLE ID# LQ 4586**  
**SAMPLE TYPE: Ground Water**  
**DESCRIPTION: Picture shows the area where sample LQ4586 was obtained**

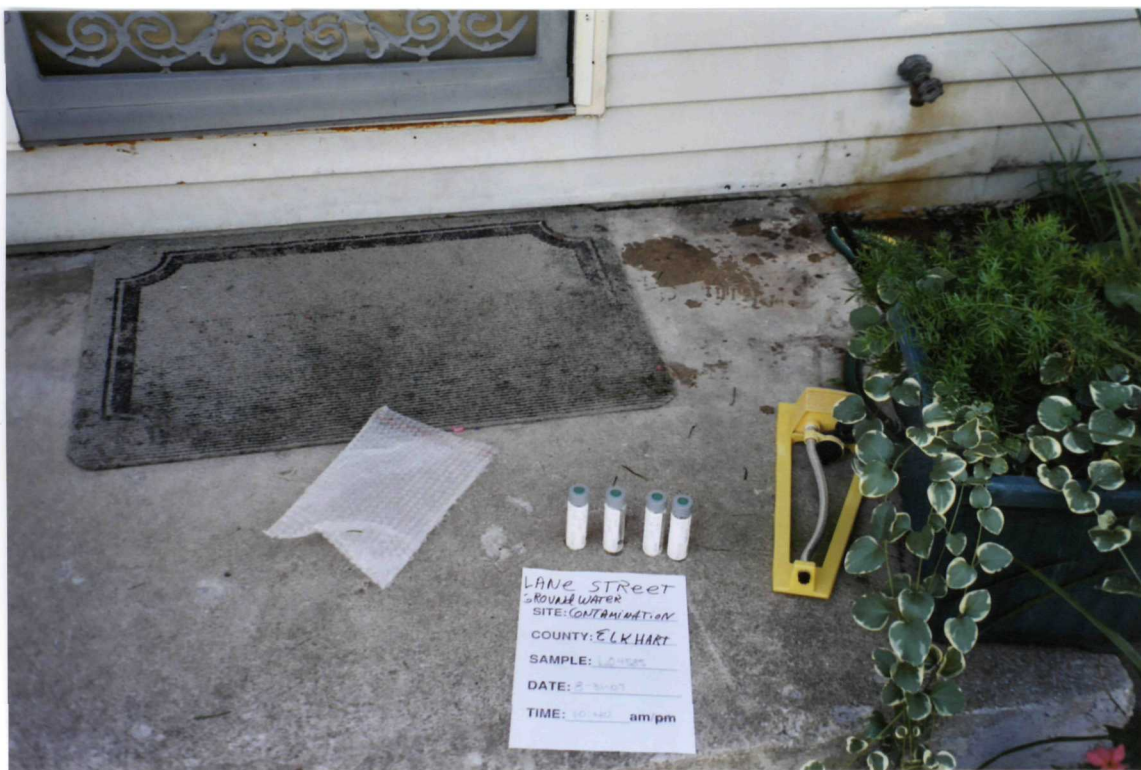
**SITE: Lane Street Ground Water Contamination**  
**EPA ID#: INN000510229**  
**DATE:8/31/07**  
**TIME: 10:40 am**  
**WEATHER: Sunny; 80s °**  
**SAMPLE ID# LQ 4585**  
**SAMPLE TYPE: Ground Water**  
**DESCRIPTION: Ground water sample obtained from 53564 Lane Street**

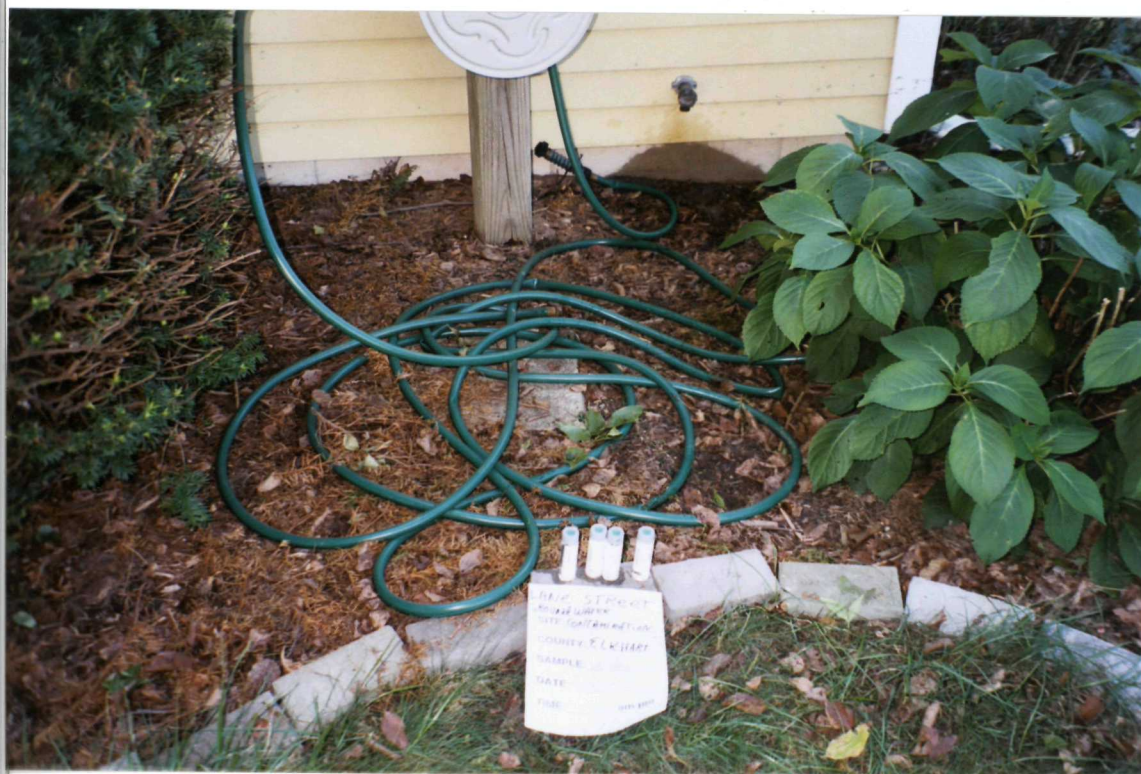
SITE: Lane Street Ground Water Contamination  
EPA ID#: INN000510229  
DATE: 8/31/07  
TIME: 10:30 am  
WEATHER: Sunny; 80s °  
SAMPLE ID# LQ 4584  
SAMPLE TYPE: Ground Water  
DESCRIPTION: Ground water sample obtained from 53548 Lane Street

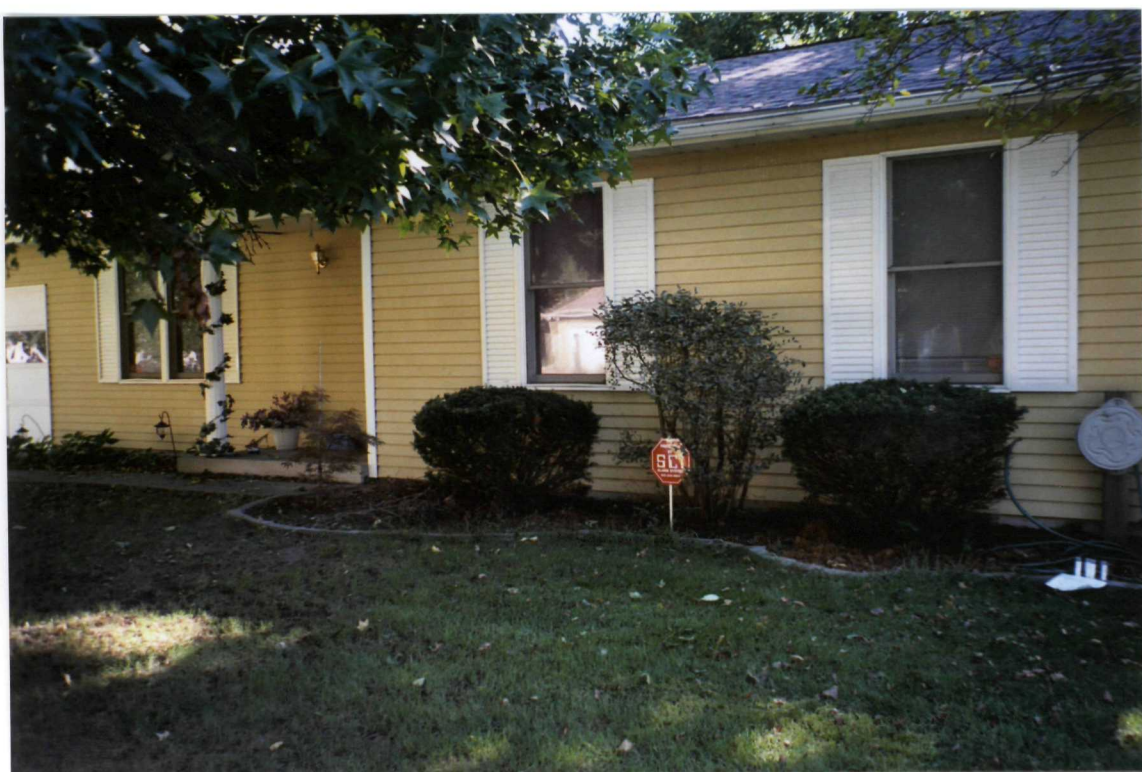
SITE: Lane Street Ground Water Contamination  
EPA ID#: INN000510229  
DATE: 8/31/07  
TIME: 10:30 am  
WEATHER: Sunny; 80s °  
SAMPLE ID# LQ 4584  
SAMPLE TYPE: Ground Water  
DESCRIPTION: Picture shows the area where sample LQ4584 was obtained

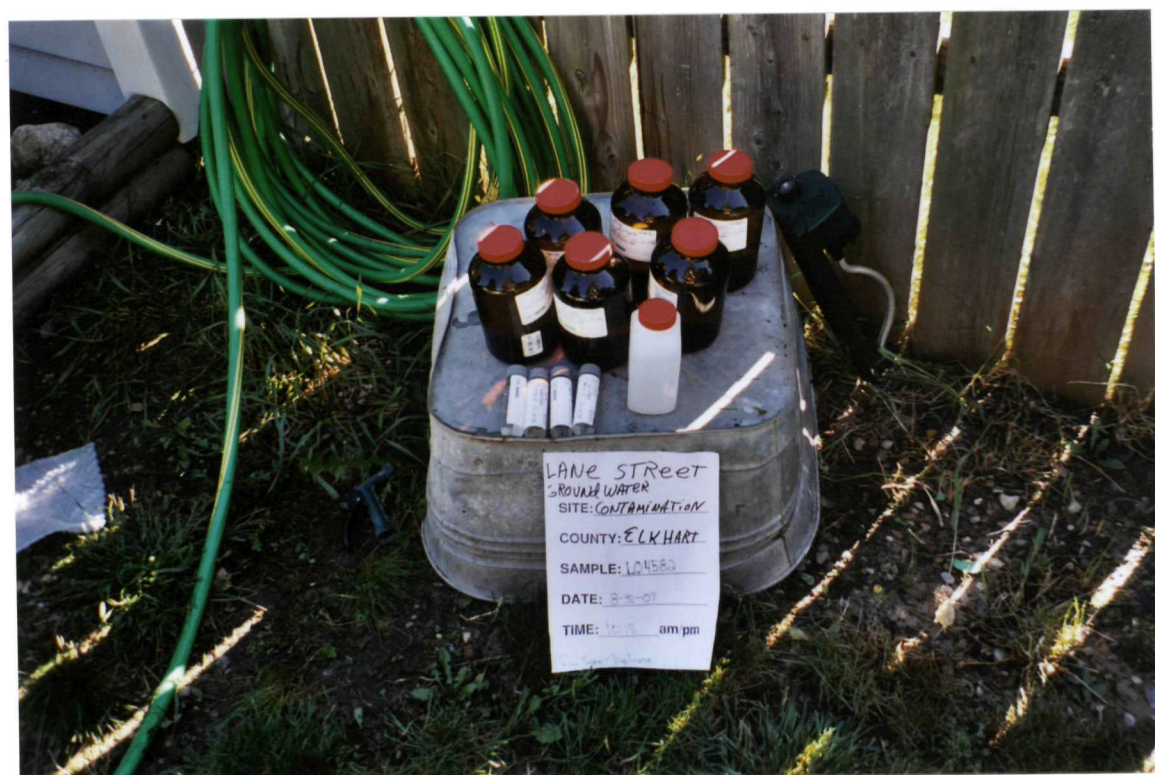
SITE: Lane Street Ground Water Contamination  
EPA ID#: INN000510229  
DATE: 8/31/07  
TIME: 10:30 am  
WEATHER: Sunny; 80s °  
SAMPLE ID# LQ 4582  
SAMPLE TYPE: Ground Water  
DESCRIPTION: Ground water sample obtained from 53532 Lane Street

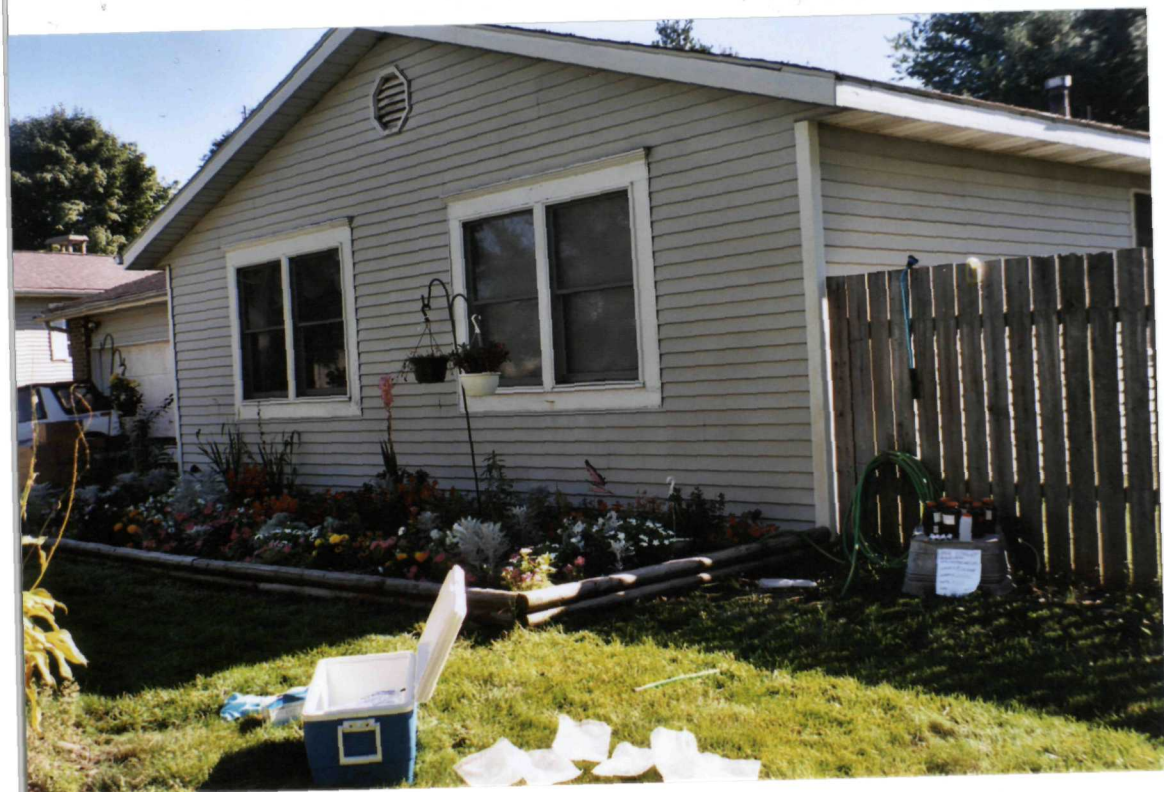
**SITE: Lane Street Ground Water Contamination**  
**EPA ID#: INN000510229**  
**DATE: 8/31/07**  
**TIME: 10:30 am**  
**WEATHER: Sunny; 80s °**  
**SAMPLE ID# LQ 4582**  
**SAMPLE TYPE: Ground Water**  
**DESCRIPTION: Picture shows the area where sample LQ4582 was obtained**

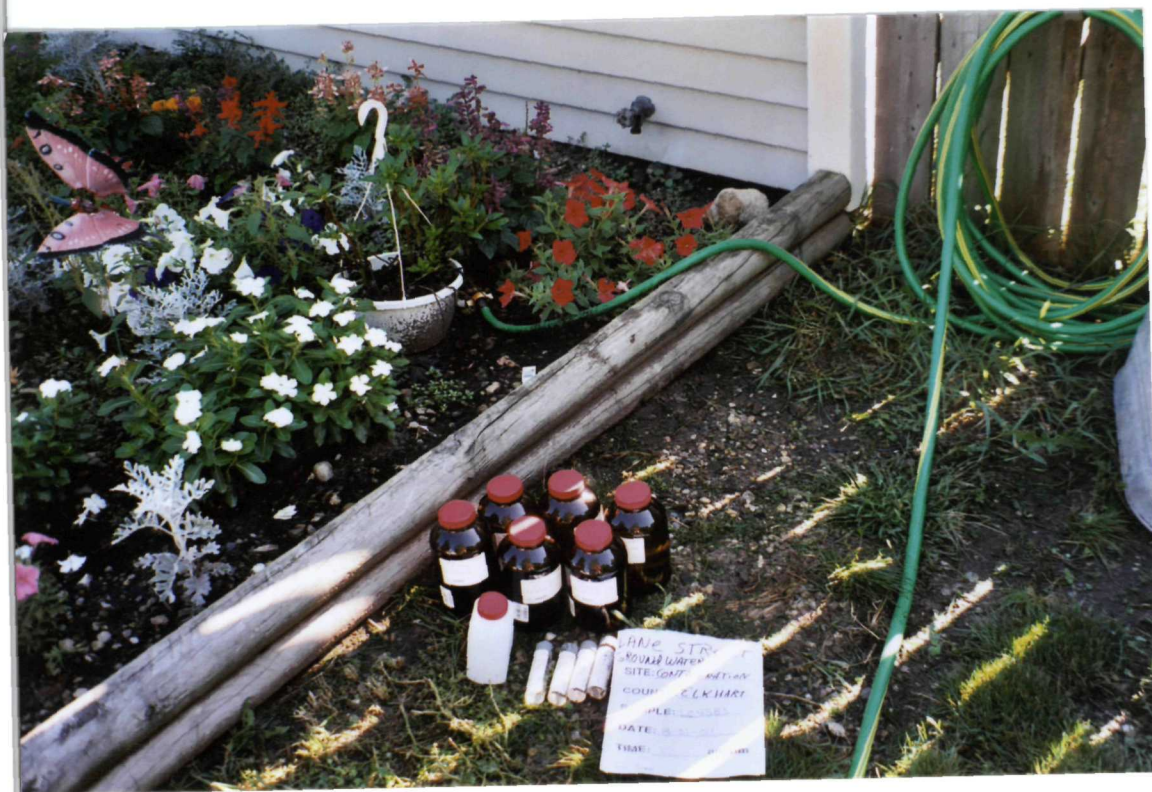
**SITE: Lane Street Ground Water Contamination**  
**EPA ID#: INN000510229**  
**DATE: 8/31/07**  
**TIME: 10:15 am**  
**WEATHER: Sunny; 80s °**  
**SAMPLE ID# LQ 4583**  
**SAMPLE TYPE: Ground Water**  
**DESCRIPTION: Ground water sample obtained from 53532 Lane Street**

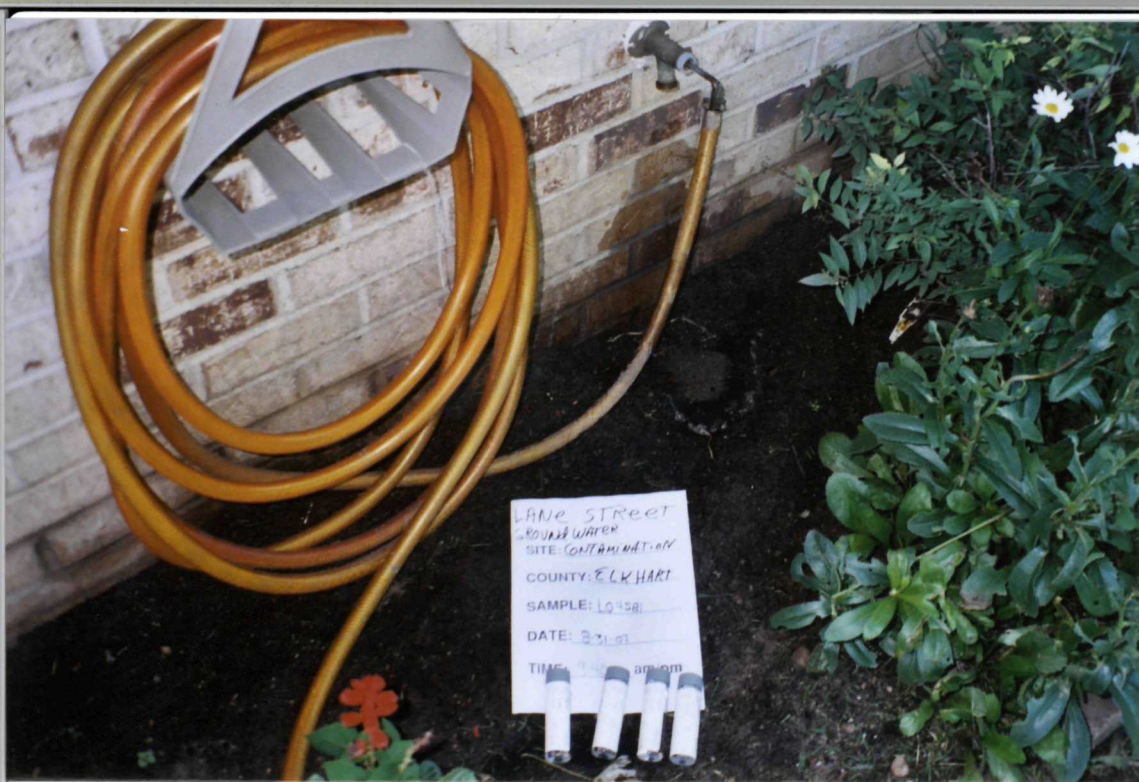
**SITE: Lane Street Ground Water Contamination**  
**EPA ID#: INN000510229**  
**DATE: 8/31/07**  
**TIME: 10:15 am**  
**WEATHER: Sunny; 80s °**  
**SAMPLE ID# LQ 4583**  
**SAMPLE TYPE: Ground Water**  
**DESCRIPTION: Picture shows the area where sample LQ4583 was obtained**

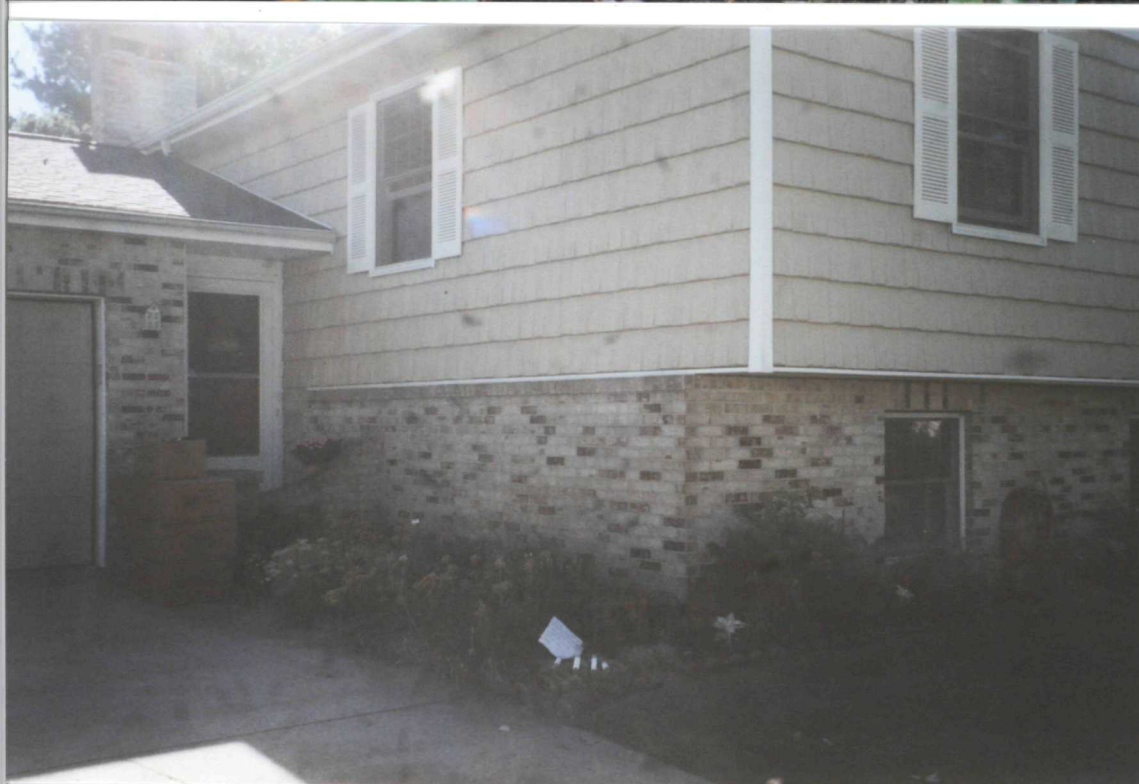
**SITE: Lane Street Ground Water Contamination**  
**EPA ID#: INN000510229**  
**DATE:8/31/07**  
**TIME: 9:40 am**  
**WEATHER: Sunny; 80s °**  
**SAMPLE ID# LQ 4581**  
**SAMPLE TYPE: Ground Water**  
**DESCRIPTION: Ground water sample obtained from 53514 Lane Street**

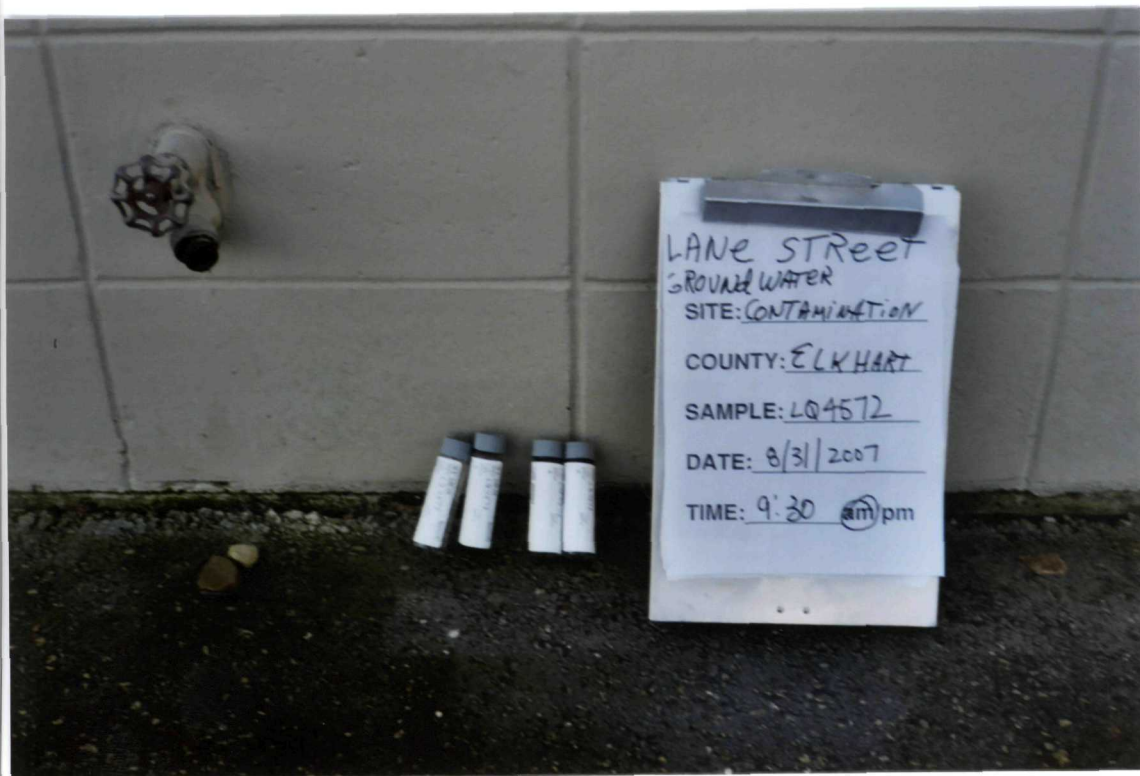
**SITE: Lane Street Ground Water Contamination**  
**EPA ID#: INN000510229**  
**DATE: 8/31/07**  
**TIME: 7:50 am**  
**WEATHER: Sunny; 80s °**  
**SAMPLE ID# LQ 4570**  
**SAMPLE TYPE: Ground Water**  
**DESCRIPTION: Picture shows the area where sample LQ4570 was obtained**

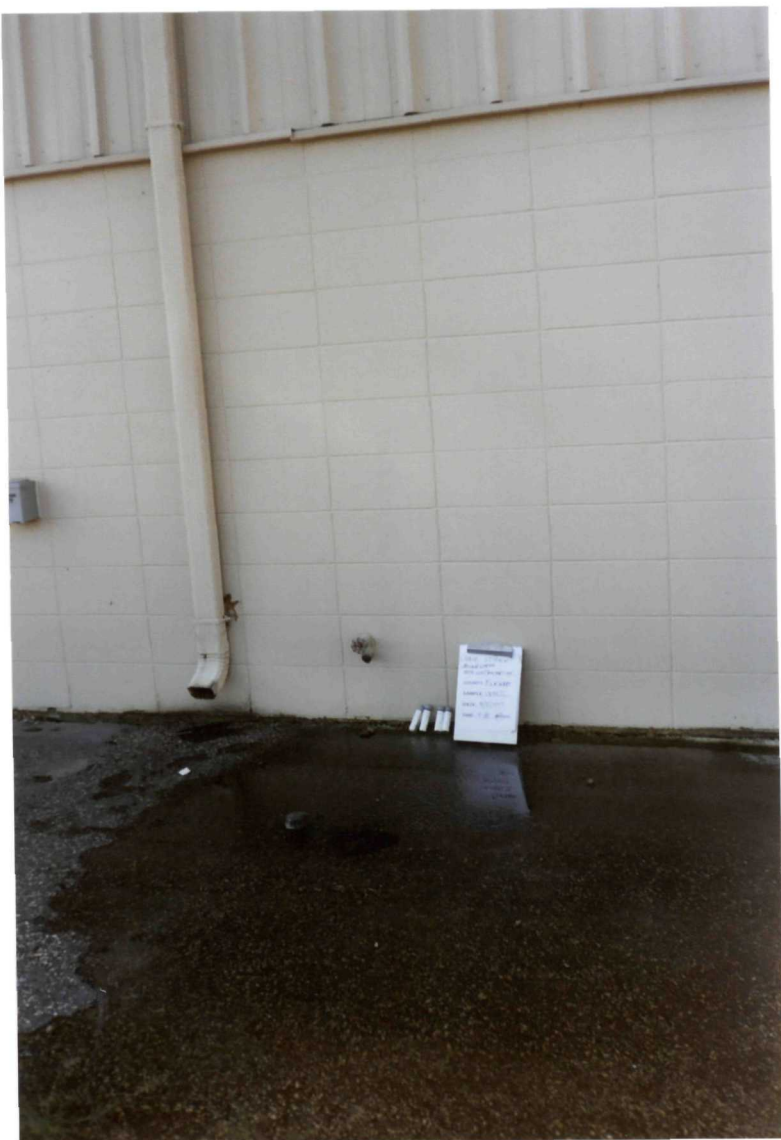
**SITE: Lane Street Ground Water Contamination**  
**EPA ID#: INN000510229**  
**DATE: 8/31/07**  
**TIME: 9:30 am**  
**WEATHER: Sunny; 80s °**  
**SAMPLE ID# LQ 4572**  
**SAMPLE TYPE: Ground Water**  
**DESCRIPTION: Ground water sample obtained from 53217 Marina**

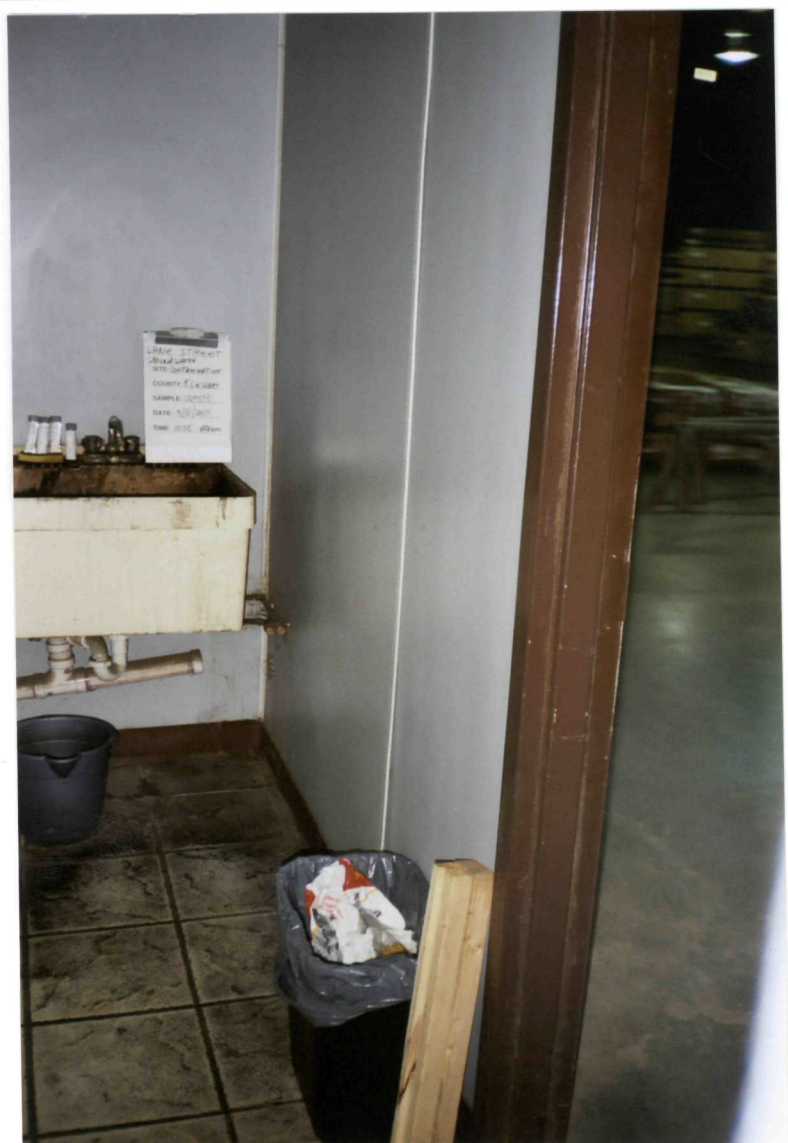
**SITE: Lane Street Ground Water Contamination**  
**EPA ID#: INN000510229**  
**DATE:8/31/07**  
**TIME: 10:05 am**  
**WEATHER: Sunny; 80s °**  
**SAMPLE ID# LQ 4573**  
**SAMPLE TYPE: Ground Water**  
**DESCRIPTION: Ground water sample obtained from 23551 Cooper**

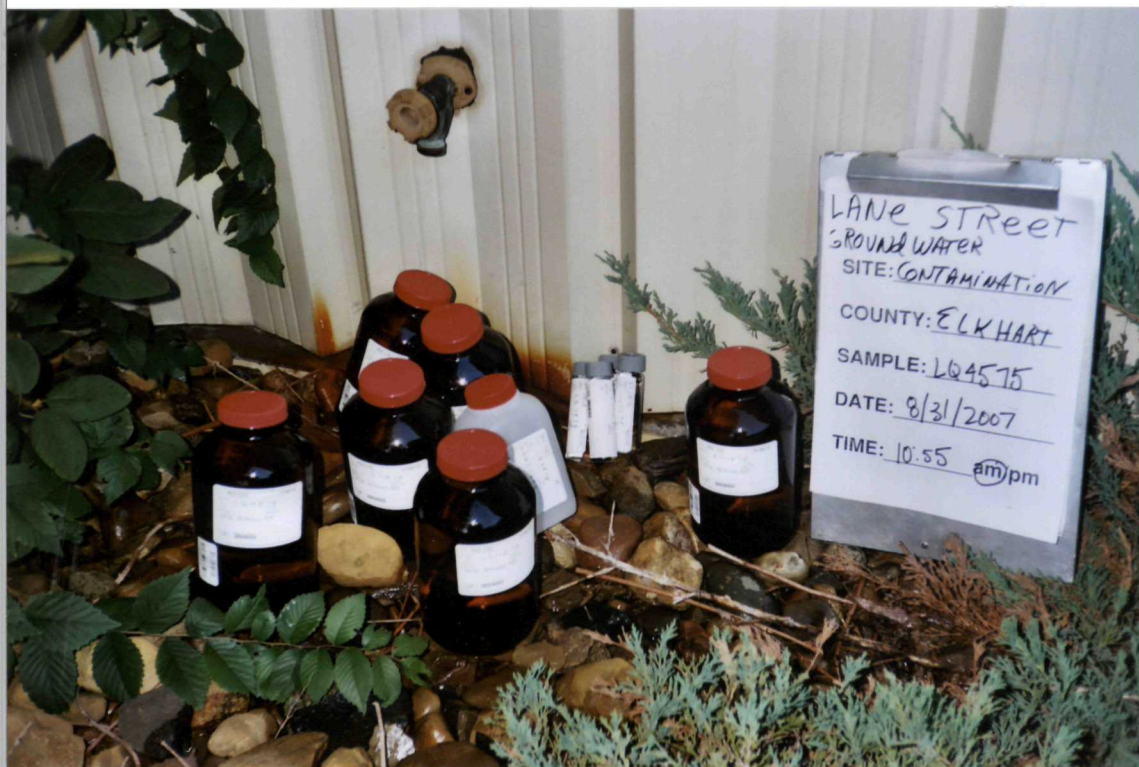
**SITE: Lane Street Ground Water Contamination**  
**EPA ID#: INN000510229**  
**DATE:8/31/07**  
**TIME: 10:05 am**  
**WEATHER: Sunny; 80s °**  
**SAMPLE ID# LQ 4573**  
**SAMPLE TYPE: Ground Water**  
**DESCRIPTION: Picture shows the area where sample LQ4573 was obtained**

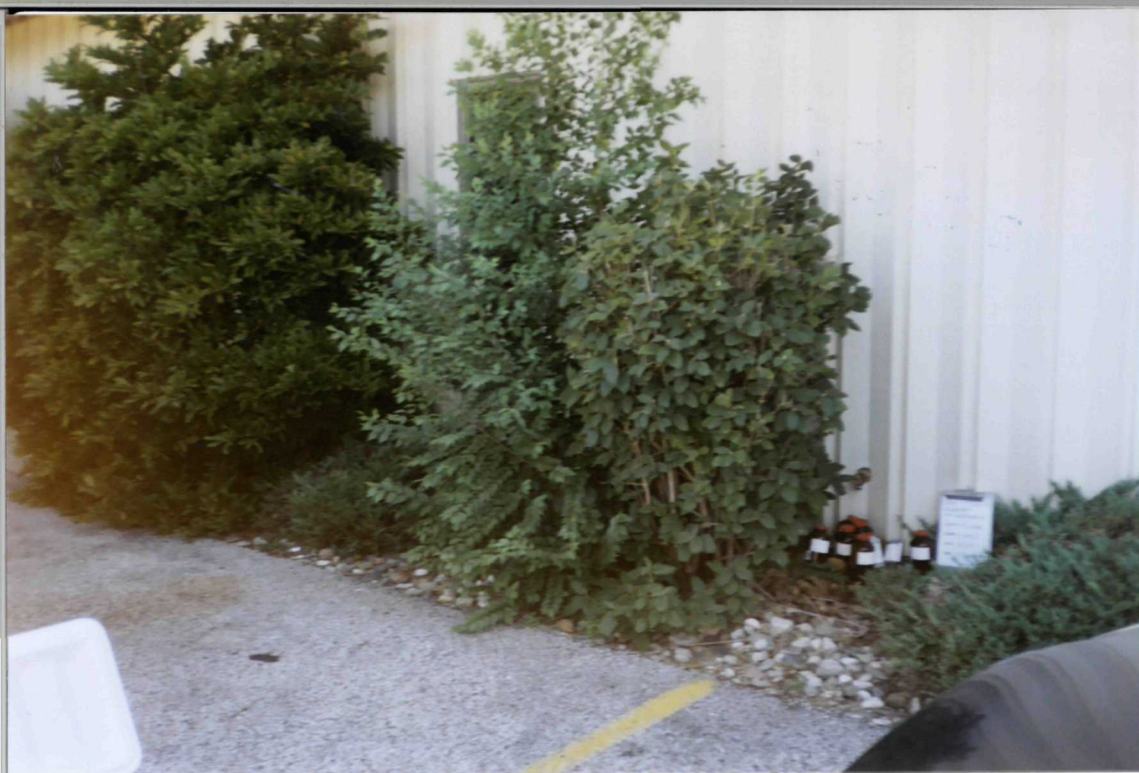
**SITE: Lane Street Ground Water Contamination**  
**EPA ID#: INN000510229**  
**DATE:8/31/07**  
**TIME: 9:55 am**  
**WEATHER: Sunny; 80s °**  
**SAMPLE ID# LQ 4575**  
**SAMPLE TYPE: Ground Water**  
**DESCRIPTION: Ground water sample obtained from 53386 Ada Street**
